# HOME INSPECTIONS

Inspection Date

**Sat, May 30, 2015**

Inspection Address: **1313 Mockingbird Lane Oklahoma City, OK 73666**

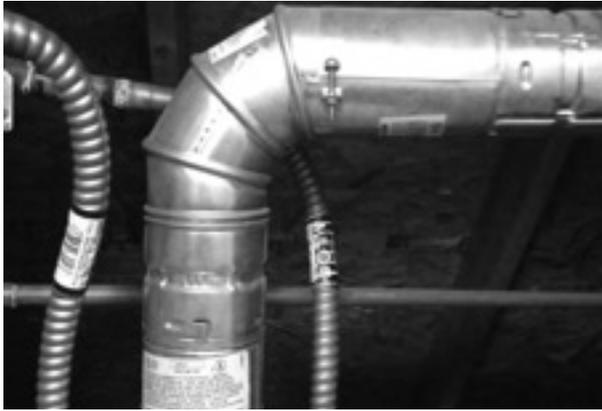
Photo 1 See Plumbing - water heater flue

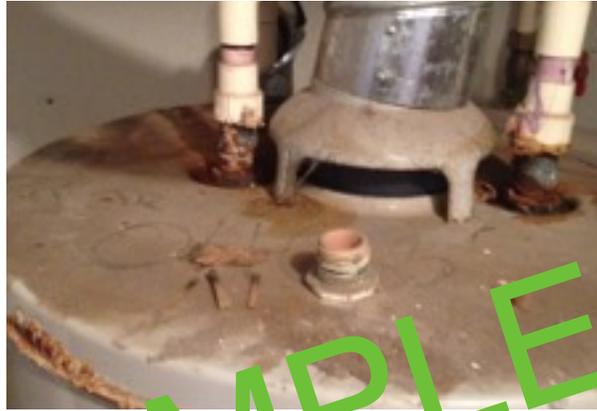
Photo 2 see plumbing water heater #2

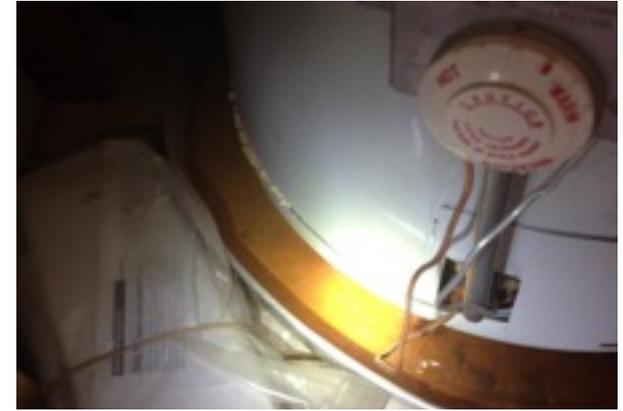
Photo 3 see plumbing water heater #2

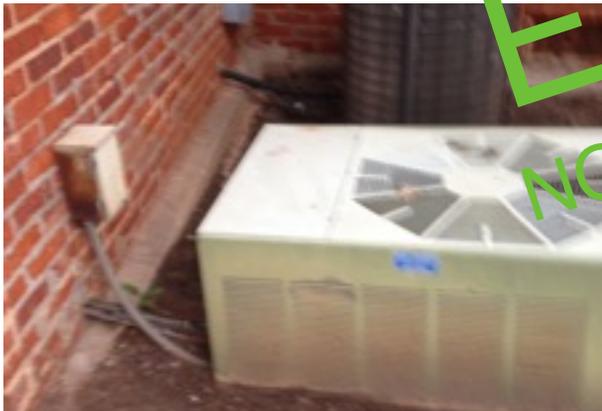
Photo 4 see hvac

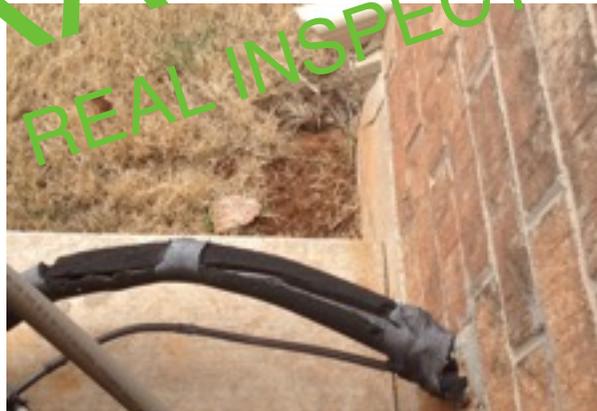
Photo 5 see hvac

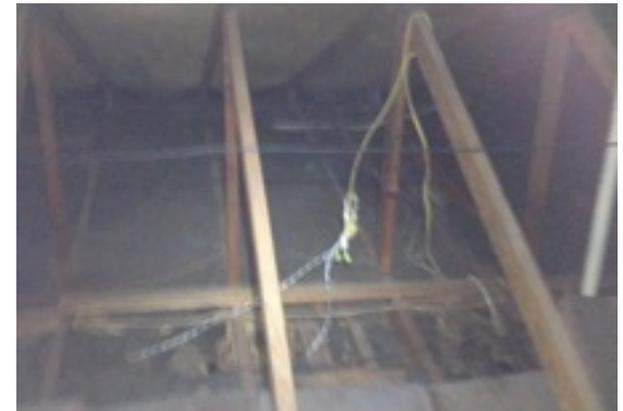
Photo 6 see attic

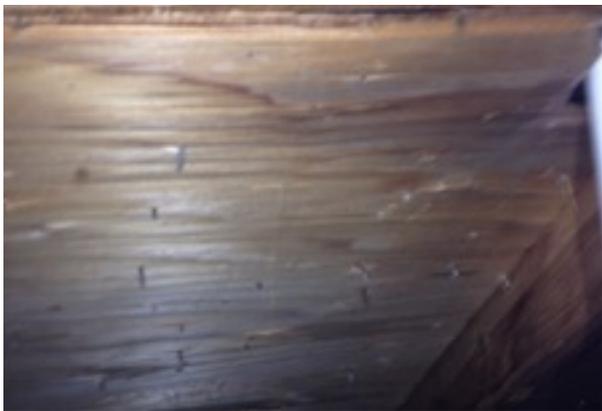
Photo 7 see attic
